## NAVAL AVIATION SAFETY CENTER

1. AIRCRAFT ACCIDENT BOARD APPOINTED BY	2. SERIAL NO	3. DTG (LOCAL) OF MISHAP	4. MODEL AIRCRAFT	5. BUREAU NUMBER
CO. VMO-5	1-57A	141245Z Apr 67	UH-1E	152437
6. TO Commander, Naval Aviation Safety Center	7. LOCATION OF MISHAP	8. TIME OF DAY	9. TIME IN FLIGHT	10. DAMAGE
VIA CO VMO-5	0680 RAD 10NM S1 Toro TACAN	NOON	0 + 26	ALPHA
CO MHTG-30	11. TYPE OF DAY	12. TIME IN FLIGHT	13. FLIGHT CODE	
CO 3dMAW	14. CLEARED FROM	15. TYPE CLEARANCE	16. AIRSPEED	17. A/C WEIGHT
CO ENRPAC	Coast Guard	VPR	60 kts E	7150
COMNAVSTA PAC	Station Pt. Vicente	18. ELEVATION AT TIME OF MISHAP	19. TERRAIN	(CRASH) 0
18. BRIEF DESCRIPTION OF MISHAP	20. LIST MODEL BUNO, REPORTING CUSTODIAN AND DAMAGE CLASSIFICATION OF ANY OTHER A/C INVOLVED	NONE		
Probable attempt at Forced Landing in Marginal Wx

VMO-5 AAR 1-67A, of 14 APRIL 1967, UH1E BUNO 152437, PILOT GREENLEESE  
"SPECIAL HANDLING REQUIRED IN ACCORDANCE WITH OPNAVINST 3750.6 SERIES"

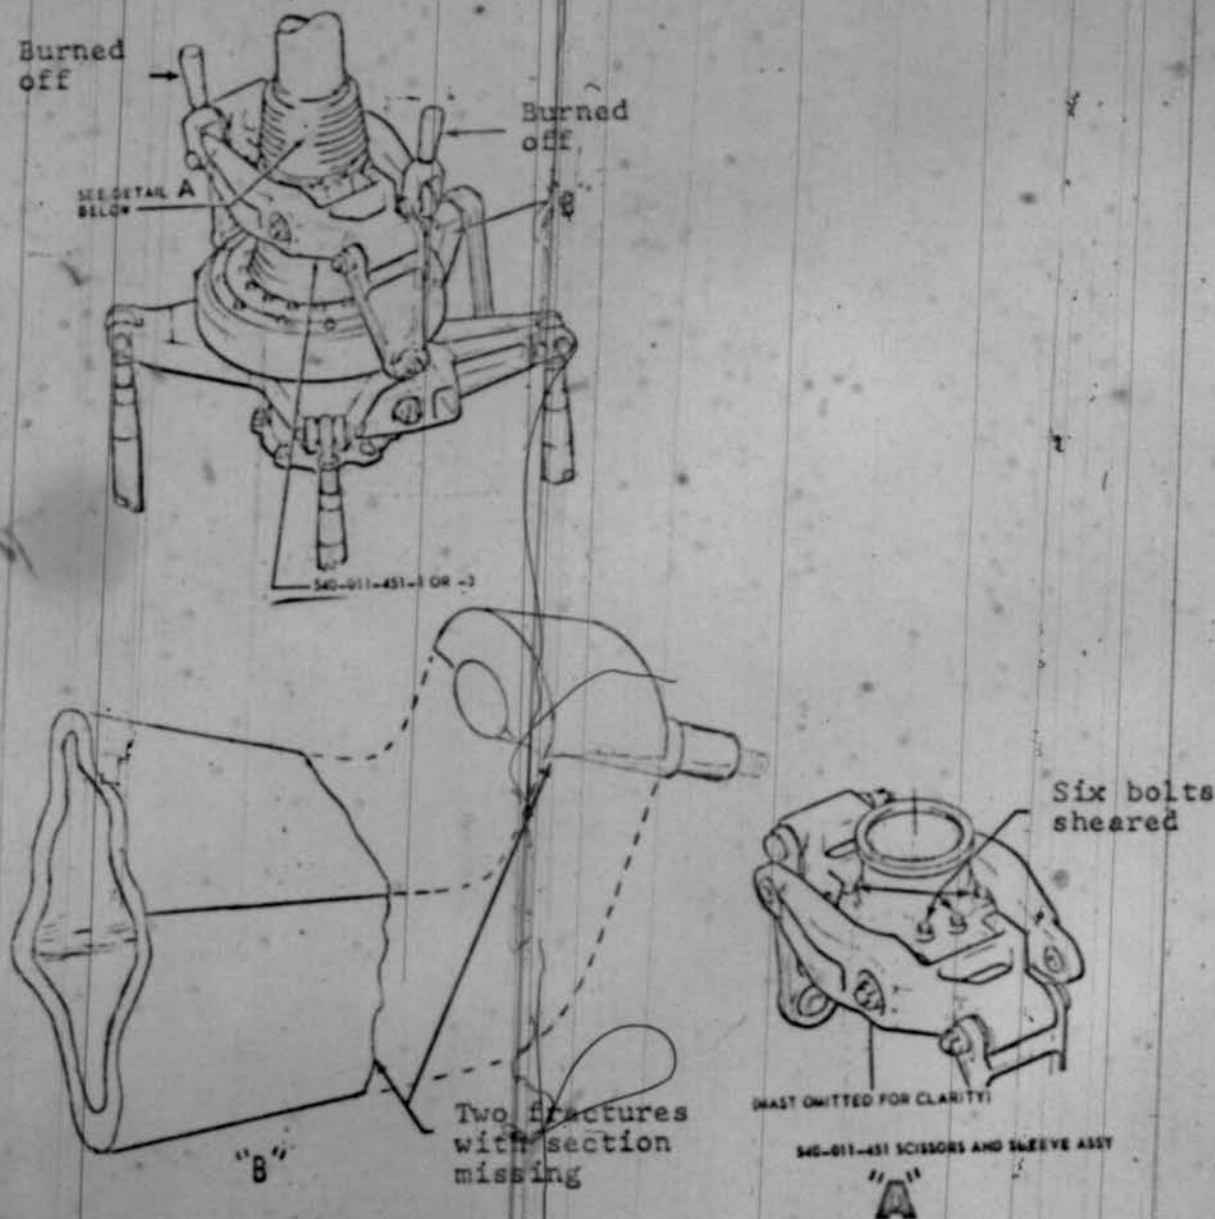
FIG. 3

SCISSORS AND SMASHPLATE FRACTURES

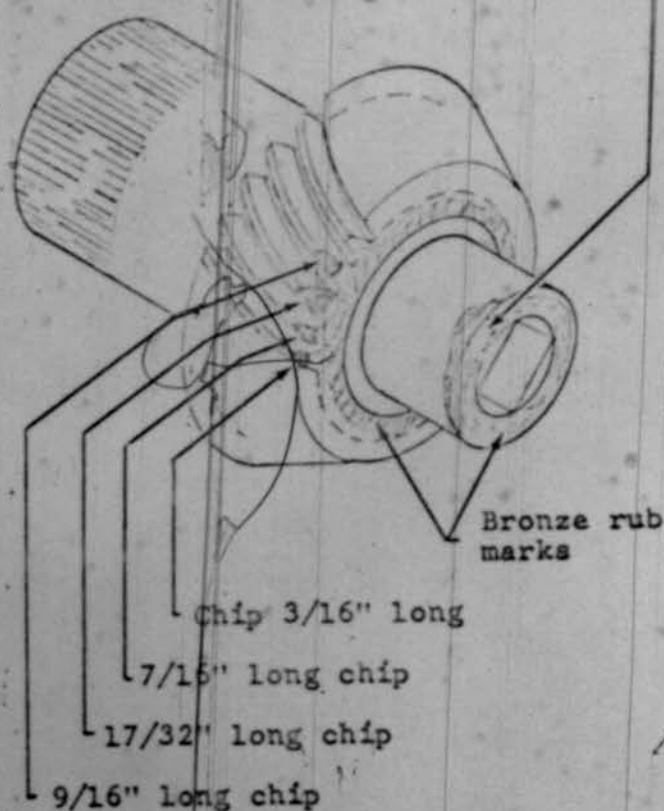
FIG. 4

204-040-700 PINION DAMAGE

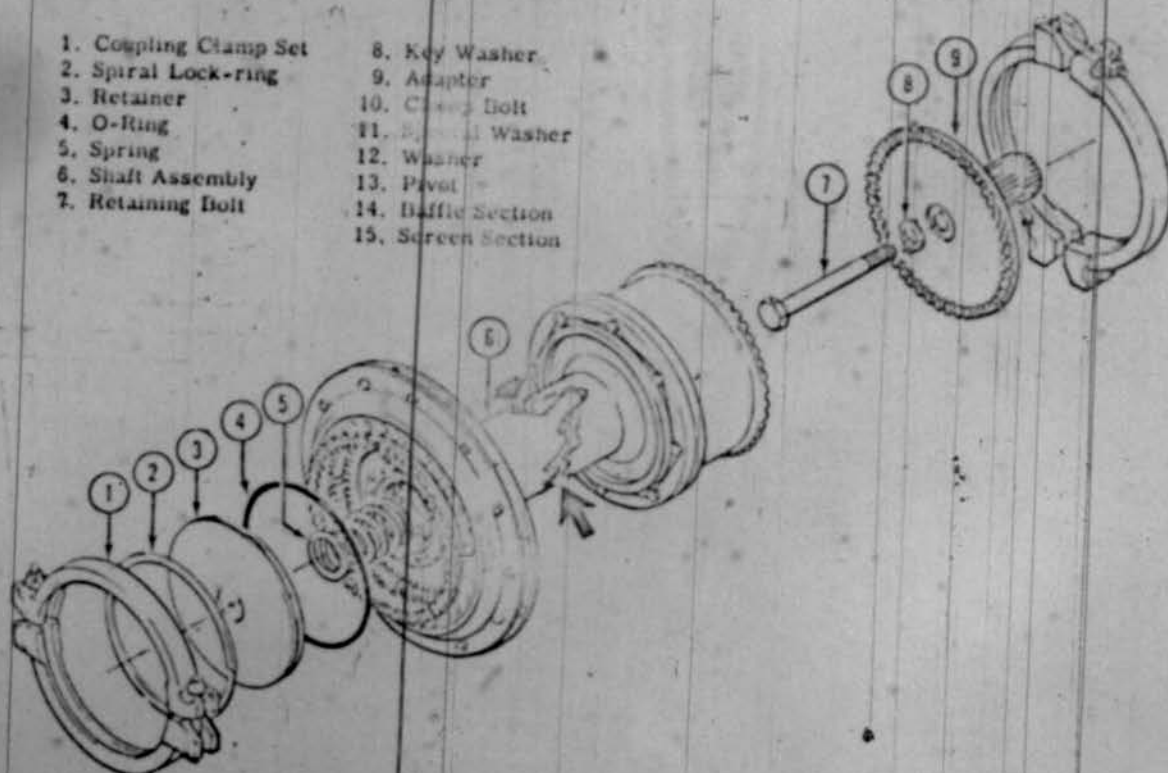
FIG. 5

FRACTURE LOCATION ON THE ENGINE  
TO TRANSMISSION DRIVESHAFT

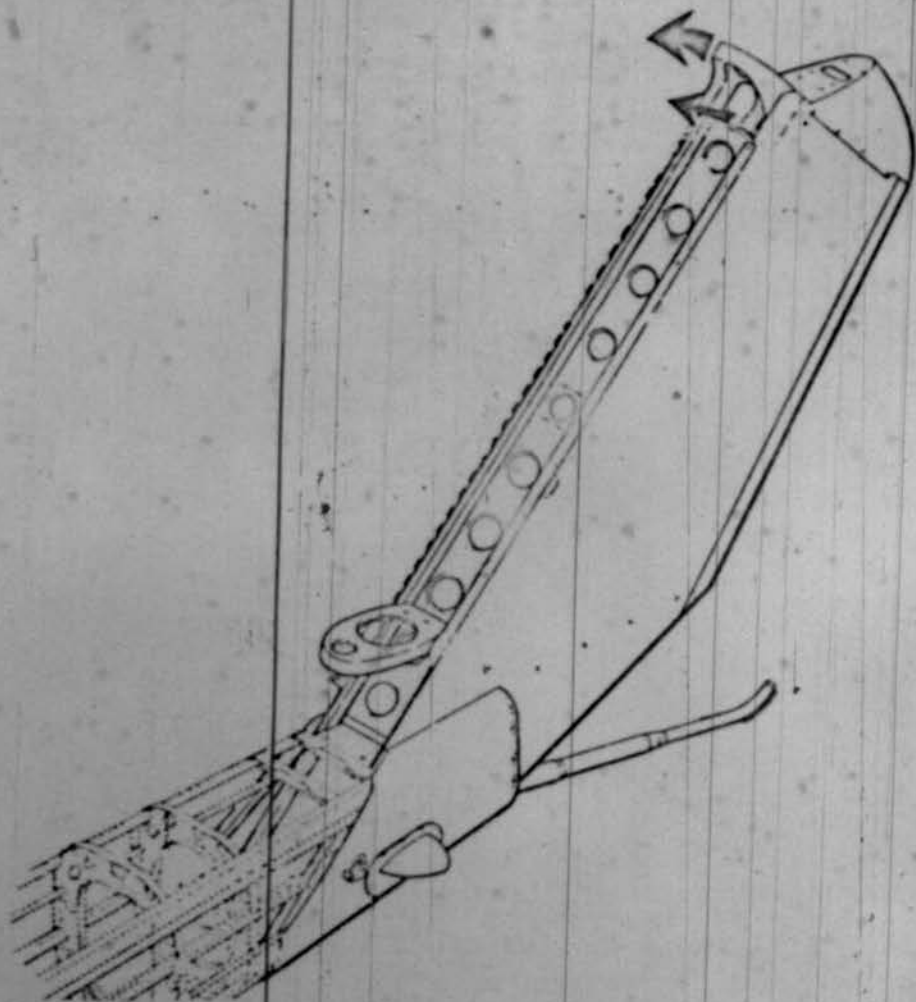
FIG. 6

DIRECTION THE 90° GEAR BOX SUPPORT CASTING  
SEPARATED FROM THE TAIL FIN

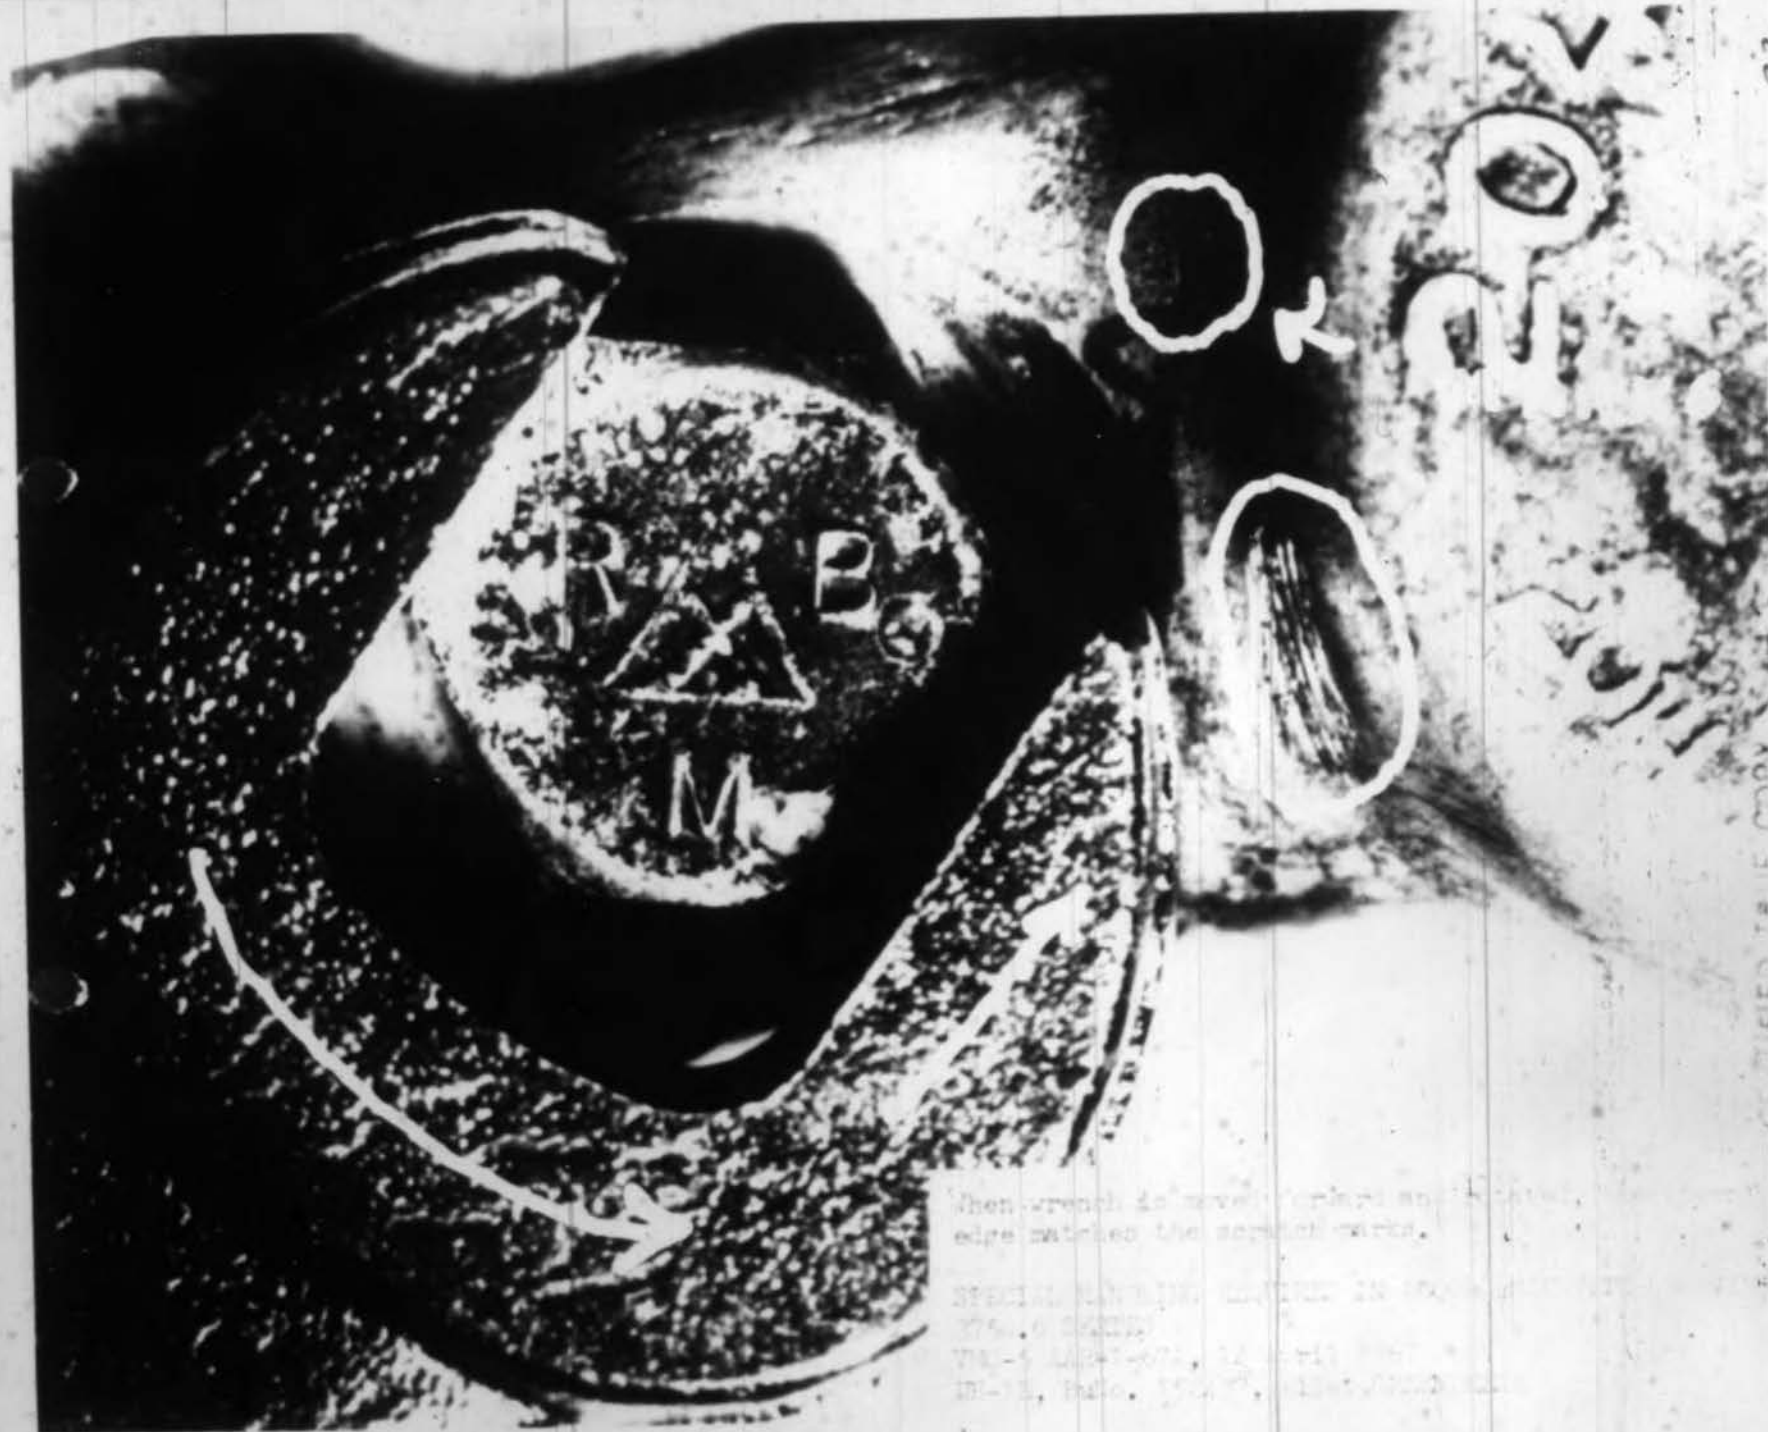
When wrench is moved forward and rotated, the  
edge matches the scratch marks.
